**DEPARTMENT OF TRANSPORTATION**

Contract #: 04-0120F4Cty: SF/ALA Rte: 80 PM: 13.2/13.9File #: 69.28**WELDING INSPECTION REPORT****Resident Engineer:** Siegenthaler, Peter**Address:** 333 Burma Road**City:** Oakland, CA 94607**Report No:** WIR-020296**Date Inspected:** 18-Dec-2010**Project Name:** SAS Superstructure**OSM Arrival Time:** 1500**Prime Contractor:** American Bridge/Fluor Enterprises, a JV**OSM Departure Time:** 300**Contractor:** Zhenhua Port Machinery Company, Ltd (ZPMC), Changxing Island **Location:** Shanghai, China**CWI Name:** Mr. Li Ping (ZPMC)**CWI Present:** Yes No**Inspected CWI report:** Yes No N/A**Rod Oven in Use:** Yes No N/A**Electrode to specification:** Yes No N/A**Weld Procedures Followed:** Yes No N/A**Qualified Welders:** Yes No N/A**Verified Joint Fit-up:** Yes No N/A**Approved Drawings:** Yes No N/A**Approved WPS:** Yes No N/A**Delayed / Cancelled:** Yes No N/A**Bridge No:** 34-0006**Component:** BAY 14 OBG**Summary of Items Observed:**

OBG BAY 14

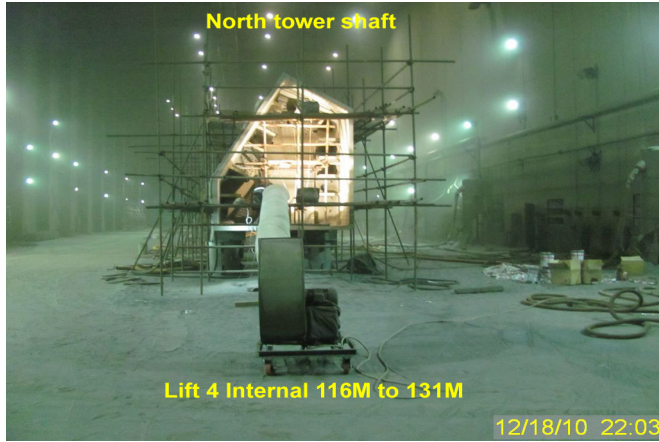
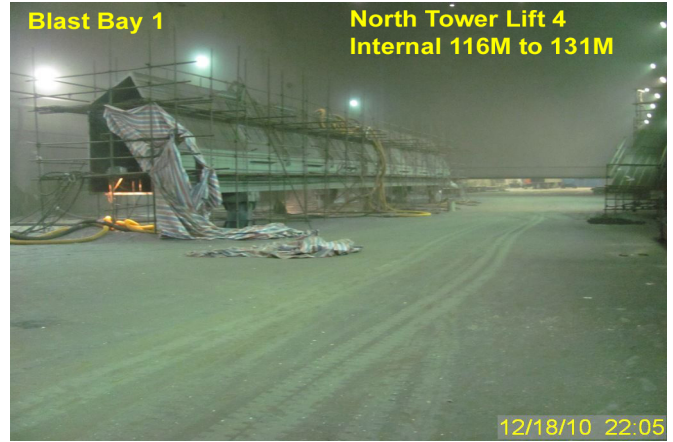
This QA inspector performed internal visual inspection of welds & base metal after blasting along with ZPMC and ABF Quality Assurance (QA) personnel. The member is identified as Tower Lift 4 – West Shaft from 116 meter to 131 meter. At 123 meter on Skin 'D' observed the following issues:

1. Crack temporary tack weld skin D, back side of 123M lower diaphragm.
2. Base metal gouge on back side of 123M upper diaphragm and skin A, near AE corner
